Tyre damage: Causes and avoidance

Car tyres 2013 - 14

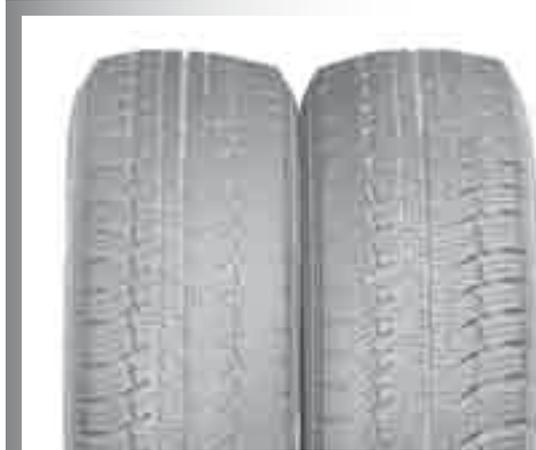
Increased, one-sided wear due to "slip". It is frequently encountered in connection with a worn tread surface. This is also often seen together with burrs along block edges up to worn tyre shoulders.

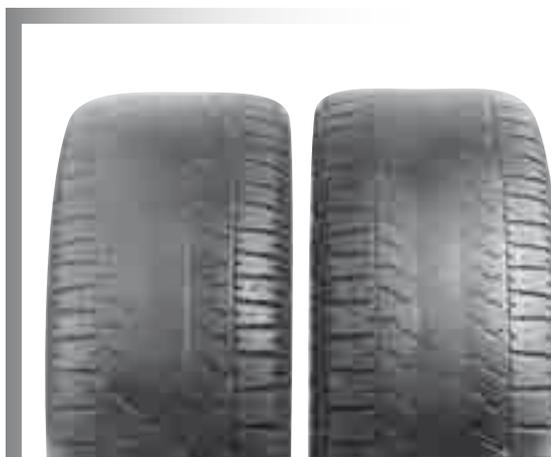
This wear pattern is found on powered wheels of highly motorised vehicles. Even today's mid-range cars have **modern engines generating high levels of torque** and capable of producing high degrees of slip.

These high torque levels, during strong acceleration or in stop-start urban traffic, or when accelerating away from traffic lights, can quickly increase wear of the tread centre.

Example of tyre wear pattern on powered axle of a powerful car: pronounced wear is visible in the tread centre.

Tip By rotating the wheels from the powered to the nonpowered axle before it is too late, it is possible to obtain a largely uniform pattern of wear. Always observe the vehicle manufacturer's recommendations.

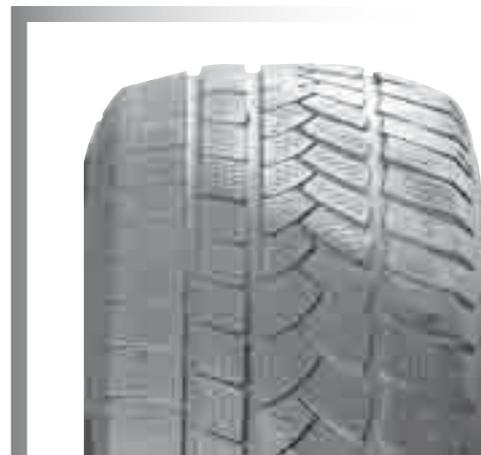
Diagonal spot wear runs at an angle of about 45° to the circumferential plane. It usually occurs on the circumference of the tyre only once, although multiple instances are also known.

Spot wear is restricted more or less to nonpowered wheel positions, especially the rear left position. Some vehicle models are particularly susceptible to spot wear, while others are not affected at all. The effect is aggravated by high toe-in values (see page 6).

This is because the toed-in tyre rolls at a slip angle, even when the vehicle is travelling straight ahead. The result is diagonal warping

Tip To avoid wear of this nature, the toe-in values should lie at the lower end of the tolerance range specified by the vehicle manufacturer. The tyres should be properly inflated. At the first sign of spot wear, the wheels concerned should be transferred to the powered axle. Vehicle manufacturer's specifications must be observed.

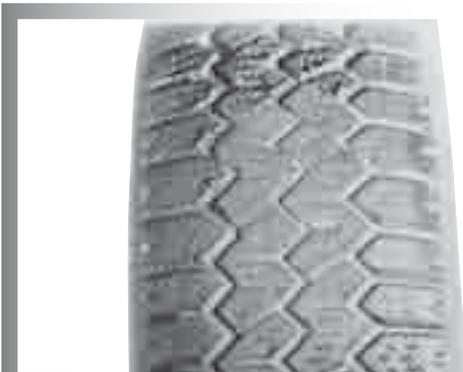
Braking flat spots are the **result of full braking** with locked wheels, causing the tyre to "lay rubber".

Severe wear due to full braking (without ABS).

Tip Extreme wear of this kind is responsible for a certain amount of vehicle vibration. This problem cannot be eliminated by balancing the wheels. The tyre can no longer be driven and must be replaced.

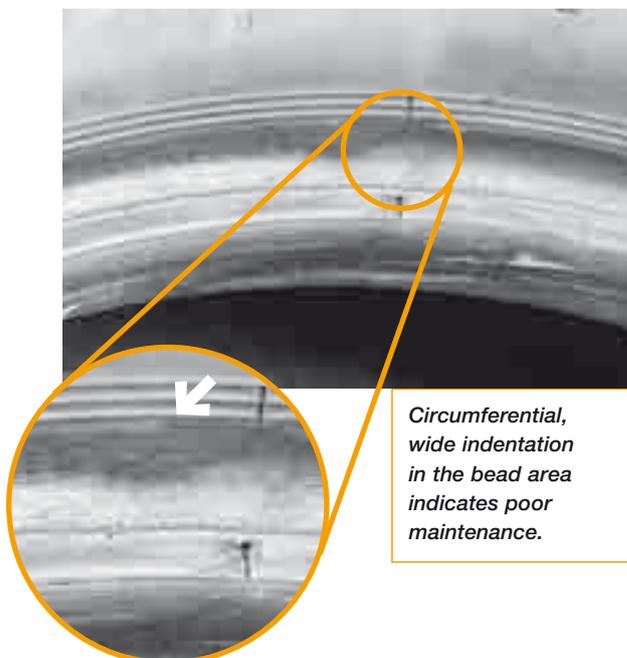
The tyre shown here was occasionally driven with inflation pressure insufficient for the load. Noticeable signs of this are circumferential, wide tracks in the bead area, where the tyre chafed against the rim flange, and shoulder wear on both sides. Discolouring or "compression wrinkling" of the inner liner at the level of the sidewall, indicate that the tyre has been driven in an underinflated state.

Circumferential, wide indentation in the bead area indicates poor maintenance.

Tip *Damage of this kind can be avoided if the tyres are regularly checked to ensure that they are correctly inflated and if care is taken not to exceed the tyre's specified load capacity.*

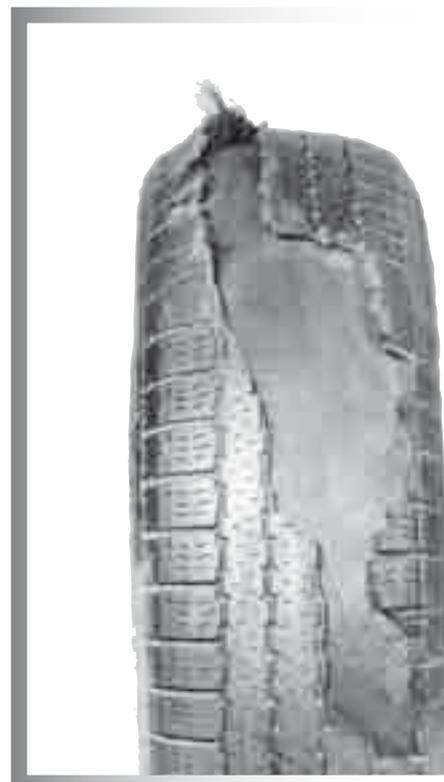
The tyre's contact patch is deformed when rolling. This can result in high shearing between different components. If a tyre is improperly serviced and driven in an underinflated state and/or with excessive load, it heats up beyond the critical temperature range, resulting in partial separation of plies (partial tyre disintegration).

Damage of this type usually develops over a longer period of time. If the already damaged tyre is then subjected to a high level of stress, parts of the tyre may detach due to the enormous centrifugal forces at work on the tyre at high speeds.

Parts of the tyre have torn off as a result of poor maintenance.

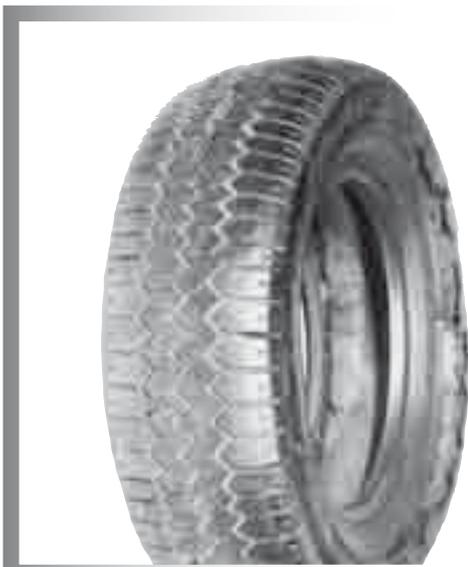
Major heat build-up in the tyre due to driving in an underinflated state led to separation of structural components and to melt-down of the rubber.

Tip Damaged valves and rims must be replaced with new ones. The valve should be replaced each time a tyre is fitted. If a direct tyre pressure monitoring system is fitted, the sealing-ring on the sensor should also be renewed. Always observe the specifications of the system manufacturer, e.g. Beru or Schrader.

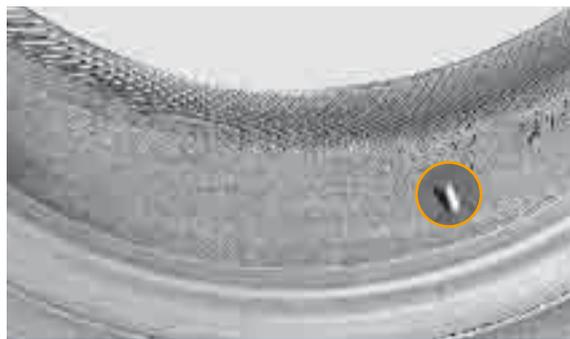
Circumferential discolorations of the sidewall in the flexing zone are indications of extended trips with falling inflation pressure or low inflation pressure.

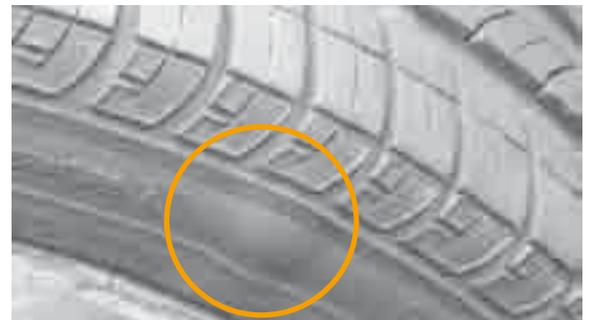
Usually an externally visible bulge on the sidewall of the tyre indicates that cords have been destroyed inside the carcass. If such damage is ignored there is the risk of tyre failure at some time in the future, usually delamination of the tread and/or plies or disintegration of the tyre flank.

Damage of this kind is typically caused by driving over objects – like kerbs or speed bumps – at excessive speed and/or at the wrong angle. This overstresses the carcass and can cause individual cords to break.

Damage seen from outside.

Tip Kerbs and similar obstacles should only be driven over at an obtuse angle and at appropriately slow speed.

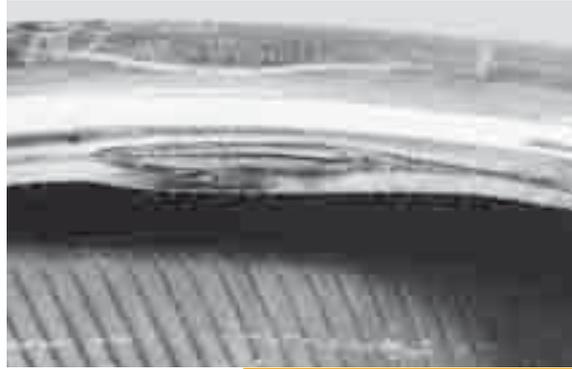
- ▶ the opposing bead section is not completely inserted in the drop centre of the rim;
- ▶ the mounting head on the machine is not properly adjusted or the mounting shoe is worn (sharp-edged);
- ▶ the edge of the mounting roller rolls off the base of the bead.

In the damaged area, the guide roller frequently leaves marks where it has made contact with the tyre. The likelihood of damage occurring increases if the guide rollers used have developed sharp-edges as a result of wear.

Bead damage caused during fitting.

Both beads and the rim shoulders must always be sufficiently lubricated before fitting. Undetected fitting damage can result in the tyre failure at a later date.

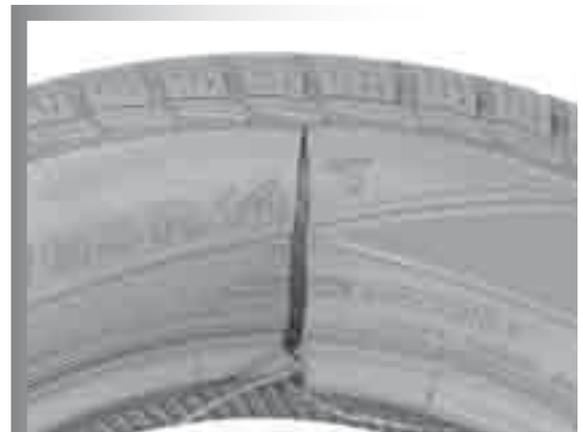
When the tyre is inflated in the process of mounting, part of the bead may get caught on the hump. In this case there is a danger of the bead excessively expanding if the tyre is overinflated and of some or all of its steel wires breaking. The pressure exerted to get the bead over the hump **must not**, for this reason, **exceed 3.3 bar**. If the tyre cannot be properly mounted at this pressure, the fitting process must be stopped. The rim flange and tyre beads should be checked to ensure that sufficient fitting lubricant has been applied. If required, additional fitting lubricant should be used. The tyres can now be fit again.

Ruptured bead as a result of tension during inflation of a tyre.

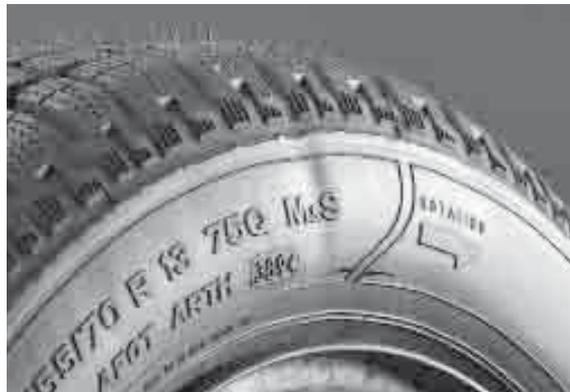
When a tyre is manufactured - or rather when constructing the carcass, to which the steel belt and the tread are then attached - there is always at least one overlapping seam.

It is this seam which is sometimes visible as an indentation after the tyre is fitted and inflated with air – although usually they are more or less invisible.

Indentation at the carcass ply overlap seam.
