Technical Bulletin – No. 13

July 2013

Full Diameter Plastic Wheel Trim Rotation / Detachment

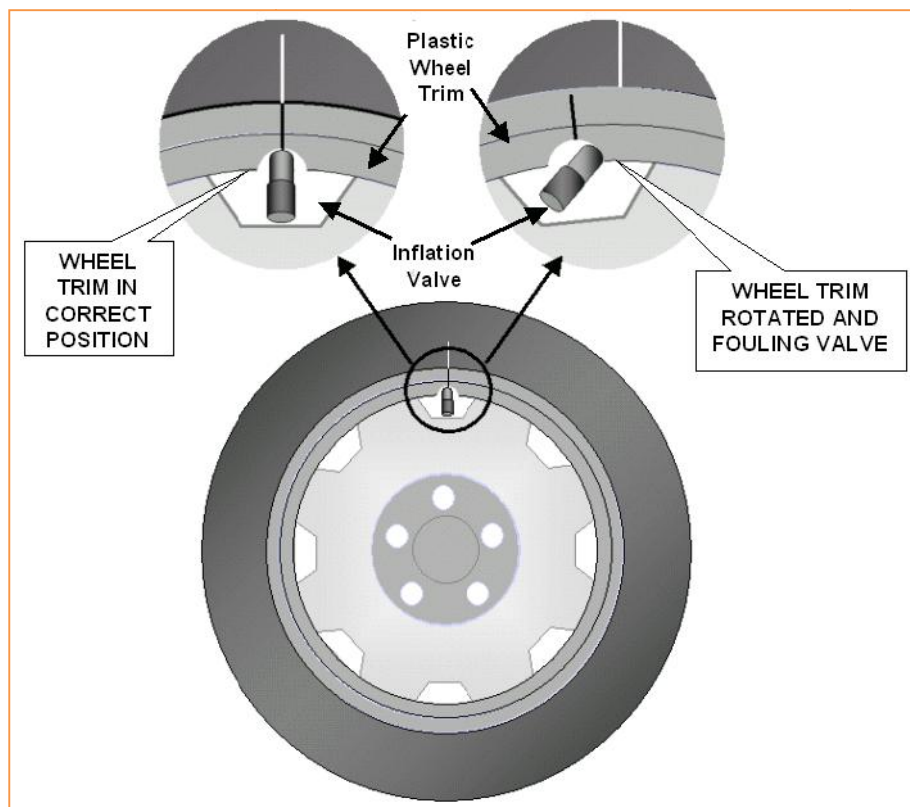
Full diameter plastic wheel embellishment trims have existed for some years and their method of fixing has significantly improved since their inception. However incidents have been reported where the trim rotates within the wheel rim and fouling the tyre inflation valve. In some cases damage to the valve has occurred resulting in air loss and tyre deflation.

Consumers are advised to check the fitting of such trims particularly when new tyres are fitted and also during periodic inspection, to ensure adequate clearance between the trim and tyre and that the trims are securely locked onto the wheel.

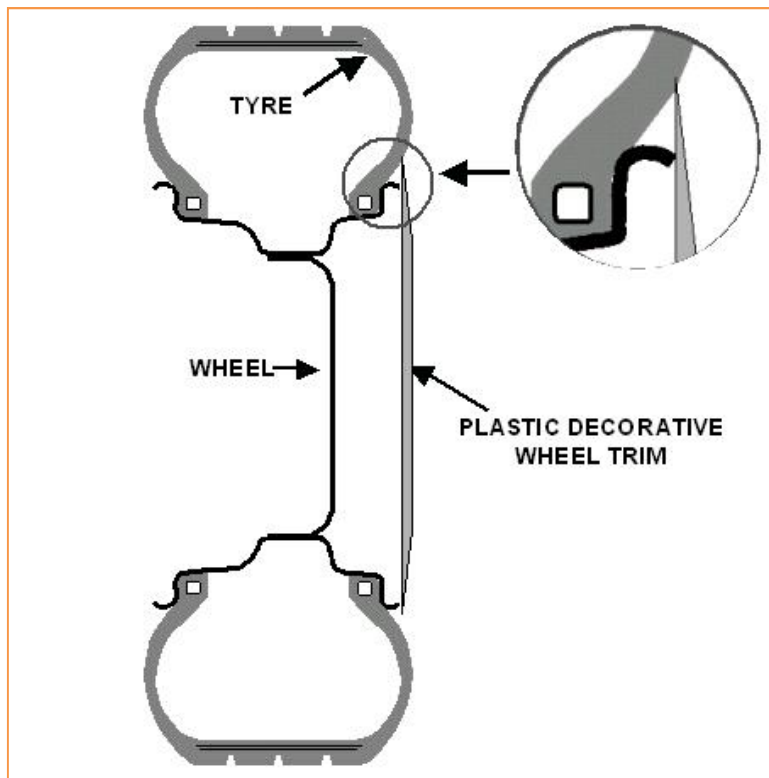
Instances have also been reported of Plastic Trims of a diameter greater than the wheel rim flange diameter and the trim fouling the tyre when the tyre is deflected under load. This has led to either the wheel trim becoming detached or chafing of the tyre, which could eventually lead to irreparable tyre damage. **This symptom is even more prevalent with tyres with built in rim flange protection i.e. designed for alloy wheels, where the tyre fits more snugly around the rim flange.**

Both the damage types described above are a symptom of the Plastic Wheel Trim design and its dimensions. They are not caused through any deficiency in the tyre design or manufacture.
