## Technical Services Bulletin Motorcycle & Scooter Tires

### Groove Cracking of Motorcycle & Scooter Tires

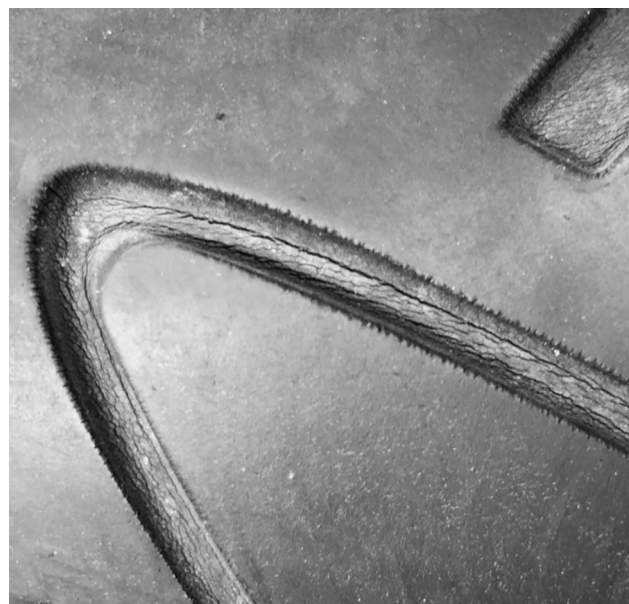
Groove cracking symptoms as shown in the photo are usually superficial and may be caused by a variety of factors other than the tire itself.

These groove cracks (also called stress cracks) are mostly caused by improper inflation pressure, excessive heat, over loading the tire or high ozone level in the environment.

The graphic below provides an illustration of the nature of the propagation of the crack. Typically groove cracks are not more than 0.5 mm (0.02") deep and do not reach the reinforcing materials of the tire.

Usually, from the point of view of the legislator, the technical inspection organizations for motor vehicle safety and also the associations of the tire industry, such crack formation is classified as harmless for operational safety.

The typical performance characteristics of the tire (e.g. wet grip, handling, mileage, rolling resistance) are not affected by the condition and we can confirm that tires exhibiting such groove cracks can continue to be used in normal service.

The symptom is therefore cosmetic and does not affect vehicle safety.
