ContiPressureCheck™

Introduction of New Features in Handheld Tool Software
Version 6.00 compared to 5.02

26. January 2015

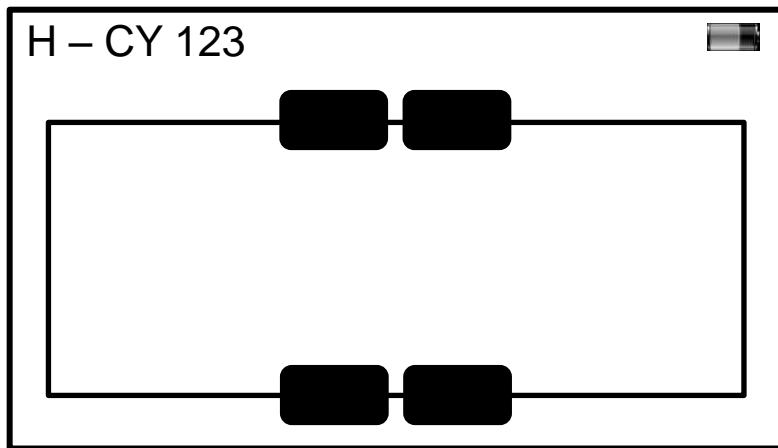
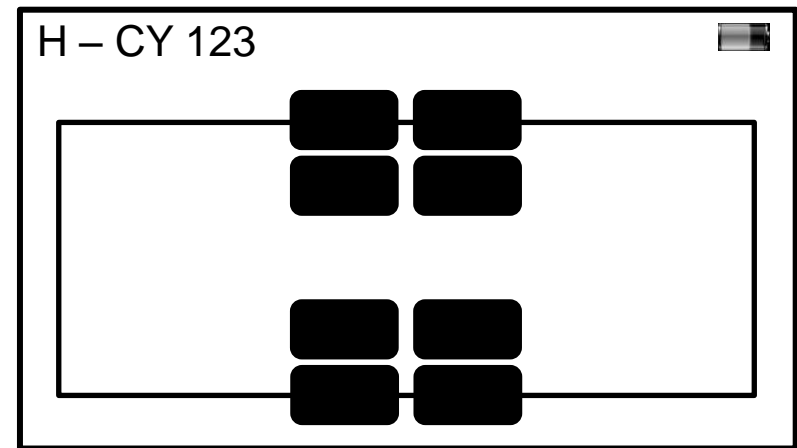
- › For the two trailer variants shown below, it was not possible to configure lift axles.
- › **With SW 6.00 this is now possible.**

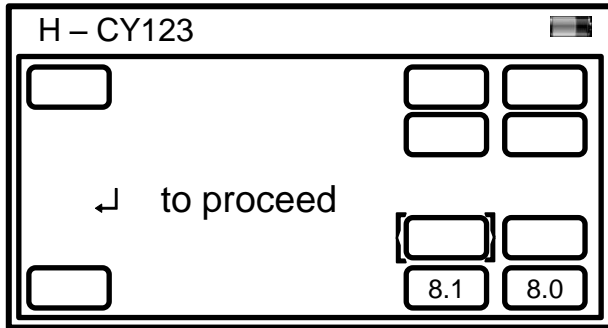
SW 5.02

Case: Sensor acquisition interrupted when 2 sensors were fetched.

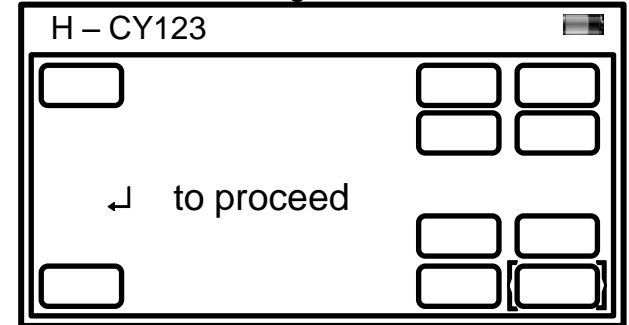
SW 5.02: Starts again with first tire.

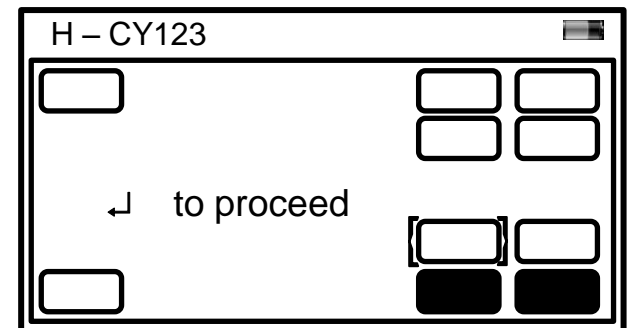
SW 6.00: Continues with third tire.

IDs of first 2 sensor are stored in HHT memory. Pressure values can't be shown, therefore the tire boxes are set to black.
