Sidewall Indentations in Radial Tyres

Technical Bulletin No. 17

UK & Ireland

Date June 2015

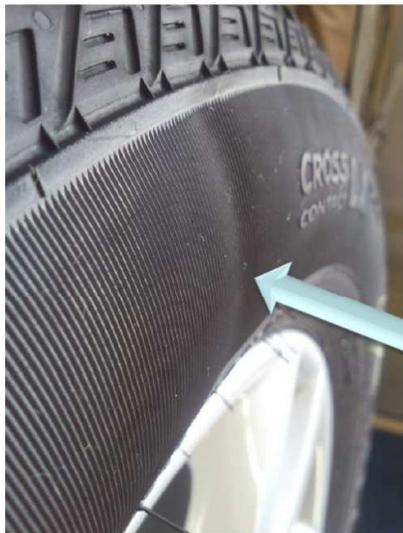
In a radial tyre, the carcass ply cords run across the tyre from bead to bead. The carcass fabric is joined using an overlap (a splice). Because the splice is an overlapping of two layers of carcass material, the strength in this area is higher than the rest of the tyre carcass. When the tyre is inflated, this over-lapped splice can create slight indentations in the sidewall.

Sidewall Indentation (inflated tyre)

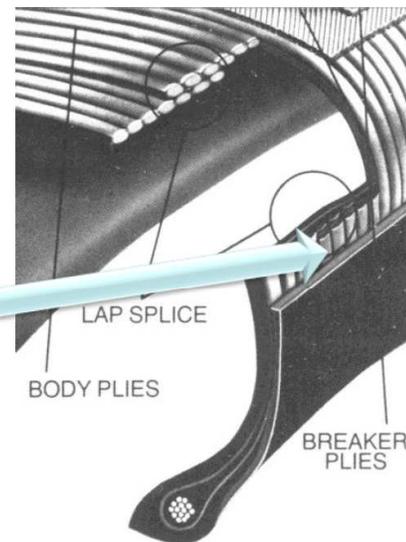
Indentation
-carcass overlapping
area-
doubled strength due to
doubled layer of cords

Diagram showing the carcass ply overlap
