Tyre damage: Causes and avoidance

Car tyres 2013 - 14

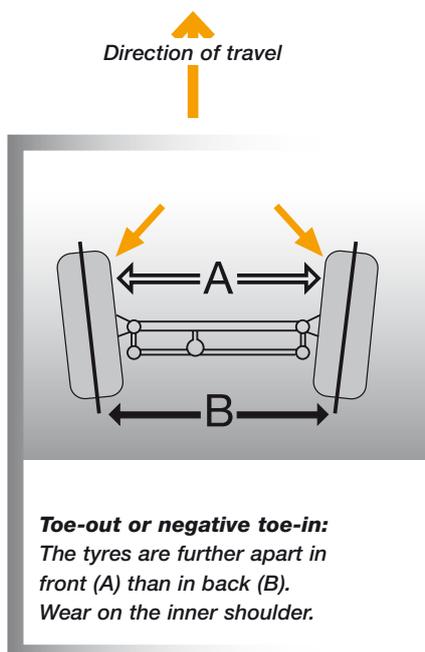
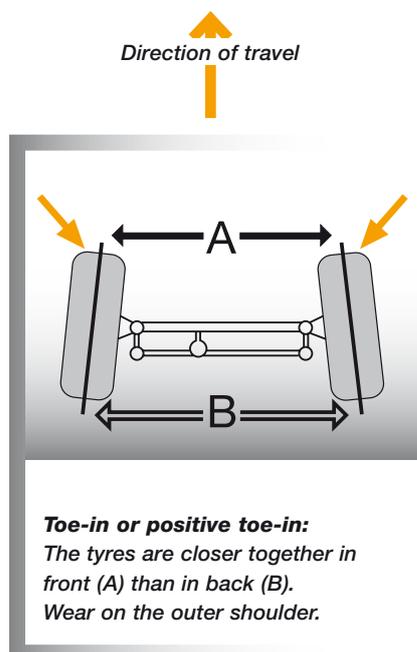
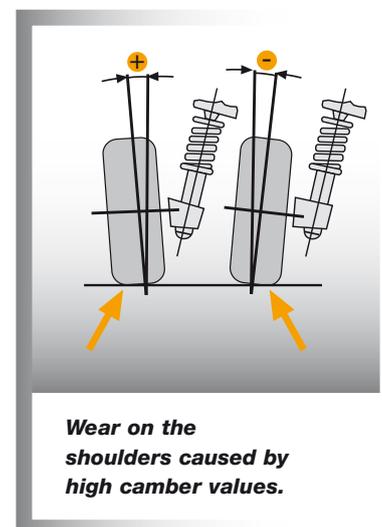
One-sided wear

The most frequent cause of one-sided wear is a **wheel geometry in deviation of specifications**.

Increased, one-sided wear due to "slip". It is frequently encountered in connection with a worn tread surface. This is also often seen together with burrs along block edges up to worn tyre shoulders.

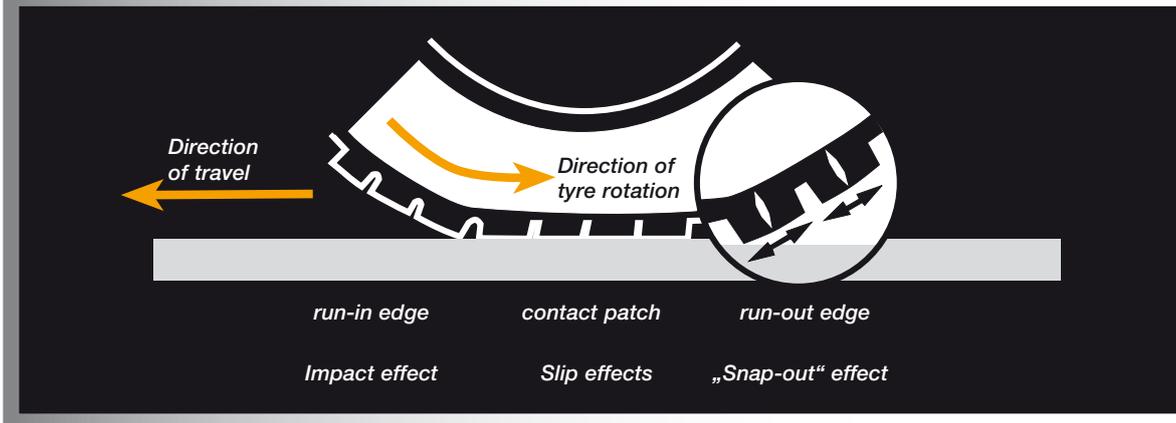
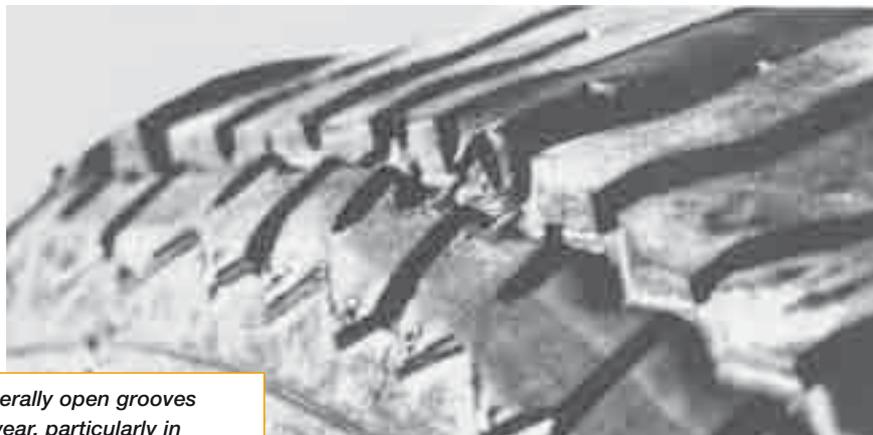
Creation of "saw-tooth wear"

Tyres with large blocks or laterally open grooves are susceptible to stepped wear, particularly in non-powered wheel positions. The blocks exhibit more pronounced wear on the rear edge (relative to the direction of tyre rotation) than on the front (leading) edge, giving the blocks a characteristic saw-tooth wear pattern when viewed from the side.

A minor amount of "saw-tooth" pattern wear is normal and has no discernible effects on comfort.

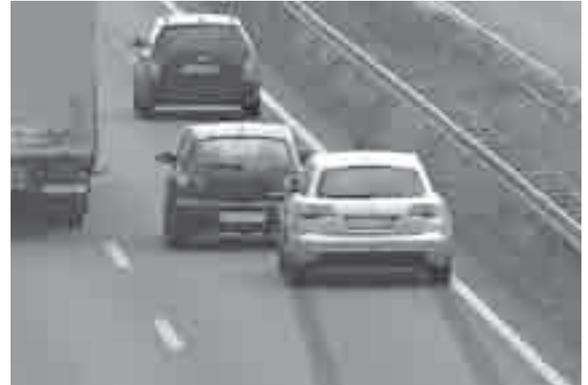
Severe wear due to full braking (without ABS).

Brakes can lock briefly even on vehicles equipped with ABS (antilock brake system), causing minor flat spotting.

Tip Extreme wear of this kind is responsible for a certain amount of vehicle vibration. This problem cannot be eliminated by balancing the wheels. The tyre can no longer be driven and must be replaced.

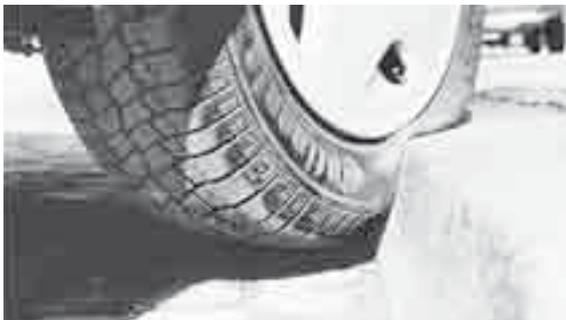
Damage seen from outside.

Tip Kerbs and similar obstacles should only be driven over at an obtuse angle and at appropriately slow speed.

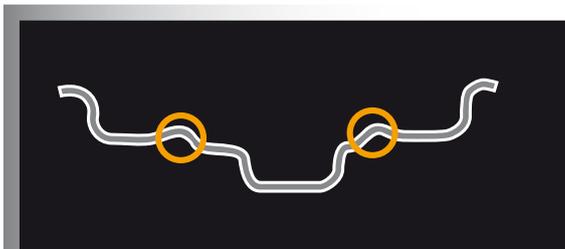
Rim profile with round hump on both sides (H2).

Tip Always use undamaged, clean and rust-free rims of the correct size which are neither deformed nor worn.
